Inspection Report

Property Address:
12345 Inspected Home
Inspection City TX 77001

Texas Real Estate Inspection Services, Inc

PROPERTY INSPECTION REPORT

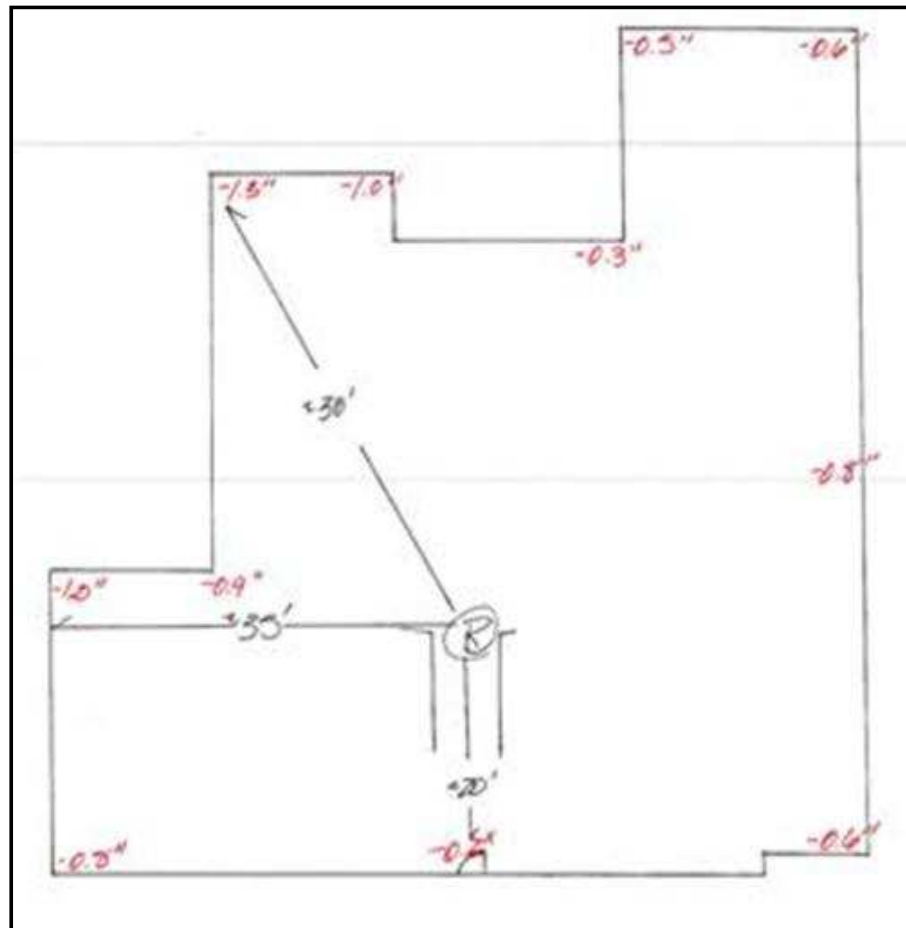
A. Picture 1

Slab on grade. Foundation appears to be functioning as intended at the time of inspection. Visible area exterior above grade and interior were observed and no defects were noted. Recommend

Foundation Elevation Readings were taken with the use of a Zip Level Pro 2000. Readings indicate that the foundation is deflected or has an elevation variance which is just over 1" in 30'. Current elevation readings with respect to a central reference point are offered here as a courtesy for the client to establish a benchmark as to the current elevation of the foundation at various points. As this firm was not present during the pour of this foundation, and have no data to disclose the engineers design or intent for this foundation, it is not possible to know if the foundation is performing or will continue to perform as intended.

maintaining/improving drainage to decrease the possibility of water ponding at points along the foundation. Ponding water can soften the ground and cause uneven settlement which can lead to foundation failure.

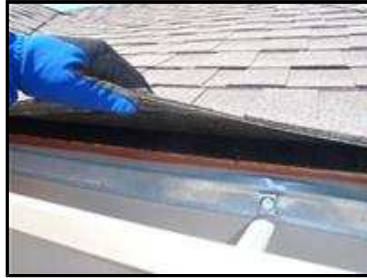
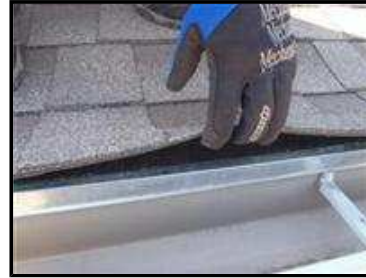
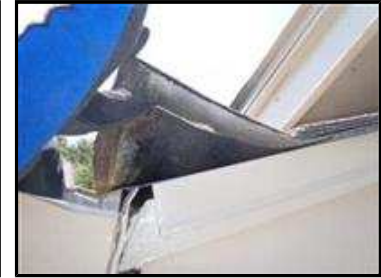
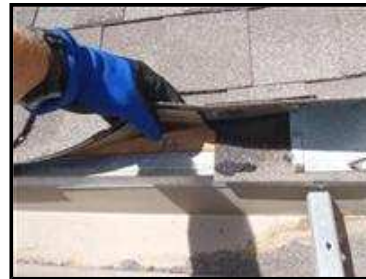
Starter course does not appear to have been properly applied to the subject roof. Shingles are not sealed and may uplift during high wind events. A qualified roofing contractor should repair as needed.

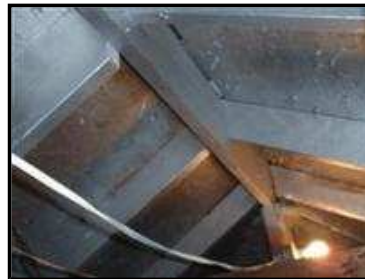
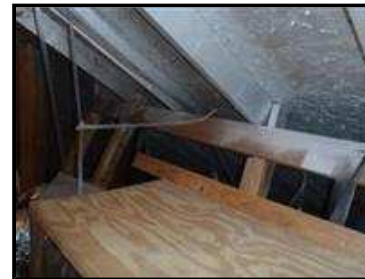
(1) The roof structure appears to be functioning as intended at the time of inspection.

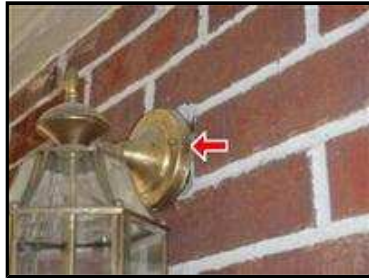
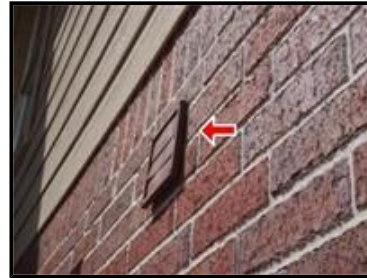
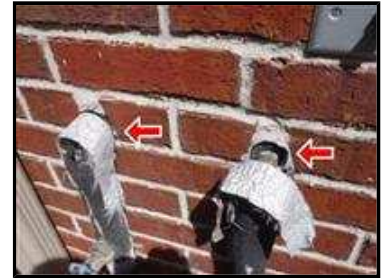
(1) Recommend sealing all exterior wall penetrations to prevent air infiltration and moisture intrusion.

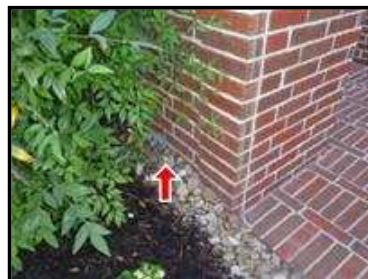
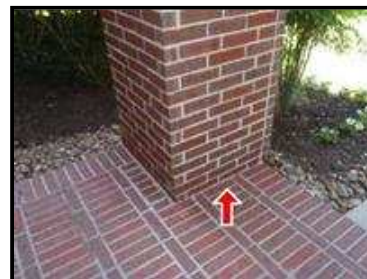
(2) It is recommended that weepholes be placed at a maximum 33" spacing along the bottom edge of a masonry wall to allow for proper drainage. If this drainage is not available, moisture can build up and lead to deterioration and fungal growth in the wall structure. The home is well equipped with weepholes with exception of, masonry columns at the front of home. Recommend the use of a minimum 3/16" masonry drill bit to create the proper holes through the mortar at the base of the wall, just above the foundation.

R703.7.6 Weepholes.

Weepholes shall be provided in the outside wythe of masonry walls at a maximum spacing of 33 inches (838 mm) on center. Weepholes shall not be less than 3/16 inch (5 mm) in diameter. Weepholes shall be located immediately above the flashing.

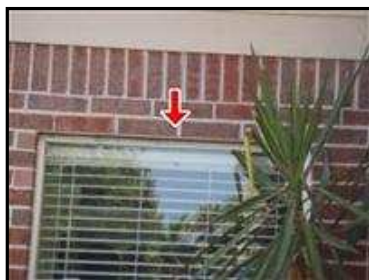
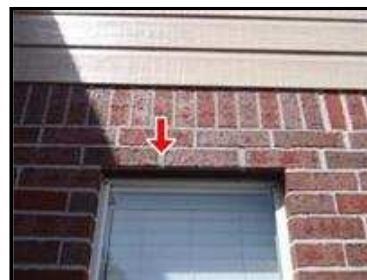
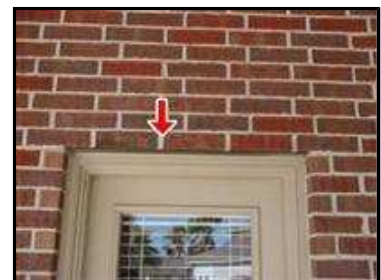
(3) It is recommended that weepholes be placed above any opening which is square in form and has a metal lintel (metal plate) above for support of a brick or rock veneer. Weepholes allow for proper drainage of a wall of this type and will prevent premature deterioration of the lintel. Weepholes can be created with the use of a minimum 3/16" masonry drill bit placing a hole just above the lintel, through the mortar left side (facing front), right side (facing front) and rear of home. This is a small repair and can be completed by a skilled individual or a contractor.

R703.7.6 Weepholes.

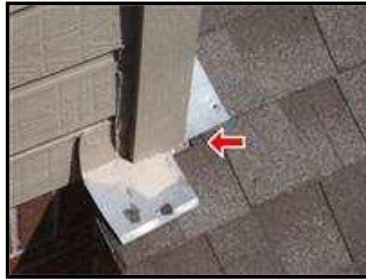
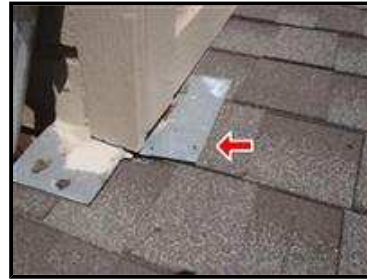
(4) Sidewall flashing is not properly applied at the left side(facing rear) on the patio cover. Damage from

water intrusion will occur. A qualified contractor should repair as needed.

(4) Sidewall flashing is not properly applied at the left side (facing rear) on the patio cover. Damage from water intrusion will occur. A qualified contractor should repair as needed.

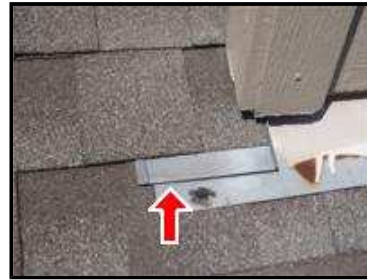
E. Picture 11

(5) Rather than use step flashing as required by the IRC, TRCC and IBC, this builder has chosen to use J flashing on wall/roof transitions. While J flashing is considered by some to be a competent flashing method and is commonly used today, it is known to allow moisture intrusion to occur and is considered by the IRC, TRCC and IBC to be deficient. Recommend a qualified roofing contractor replace this flashing with a properly assembled step flashing product. This is for your information.

R905.2.8.4 Sidewall flashing - Flashing against a vertical sidewall shall be by the step-flashing method.

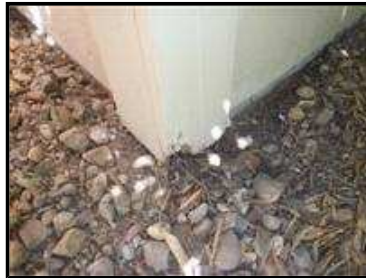
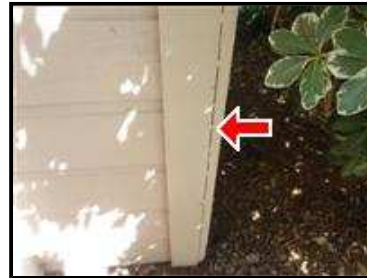
(6) Minor dry rot was noted at the base of the wood trim on the exterior of the master bedroom fireplace box. Joints are beginning to separate. Recommend repair as needed.

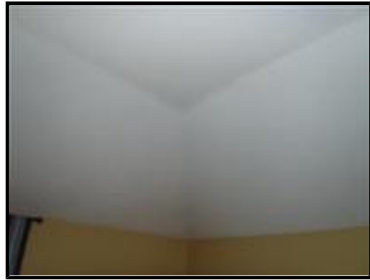
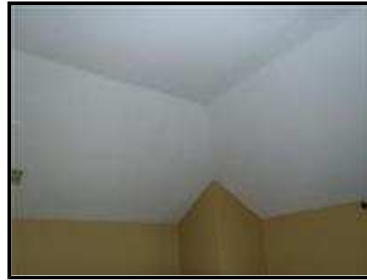
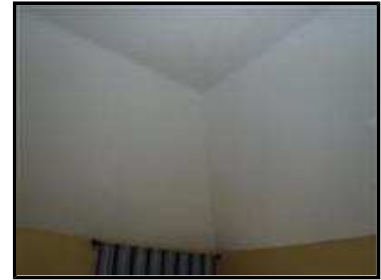
(2) Gambrel ceilings are present within the home. It is typical that these ceiling structures will, as the home settles and "racks" or moves with high winds, develop cracks and nail pops at the corner area which intersects with the vertical wall surface below. The cause is generally accepted that the sheetrock is attached to the rafters and as the roof flexes, the sheetrock moves as well. This will cause the cosmetic

issues mentioned earlier. In any case, the structure allows sheetrock is to move to the extent that small cracks will form. The solution to these cracks is to simply fill the affected area with a caulk or floating compound, prep and paint. This is not a condition that effects the functionality, safety or integrity of the structure and is mostly cosmetic in nature. This is for your information. Recommend repair or replace as needed by a qualified person.

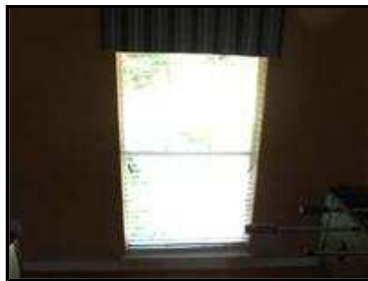
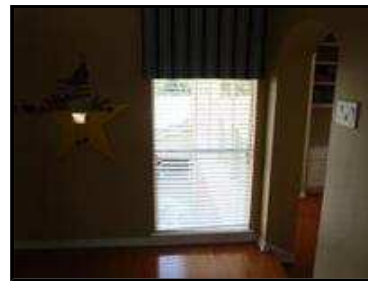
R308.4 Hazardous locations.

7. Glazing in an individual fixed or operable panel, other than those locations described in Items 5 and 6 above, that meets all of the following conditions:

7.3. Top edge more than 36 inches (914 mm) above the floor.

7.4. One or more walking surfaces within 36 inches (914 mm) horizontally of the glazing.

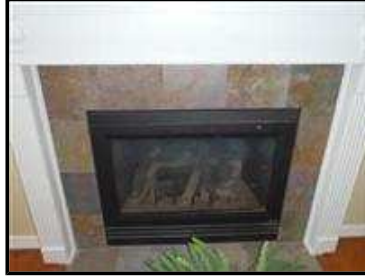
J. Picture 1

Fireplace at the bedroom does not turn off from the switch. Unit was switched off at the switch, after 5 minutes, no change. Repair as needed.

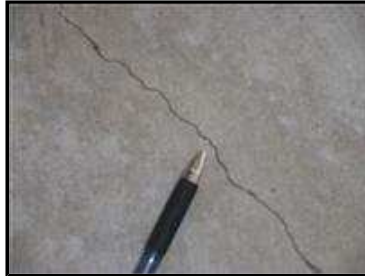
K. Picture 1

The concrete floor on the covered porch at the rear of home has cracked in some areas (which are cosmetic). This is for your information . I recommend repair as desired.

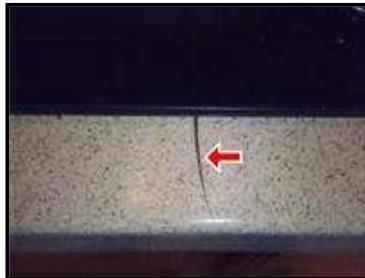
L. Picture 1

Countertop is damaged forward of the cooktop. This is a cosmetic issue for your information. Recommend repair or replace as necessary.

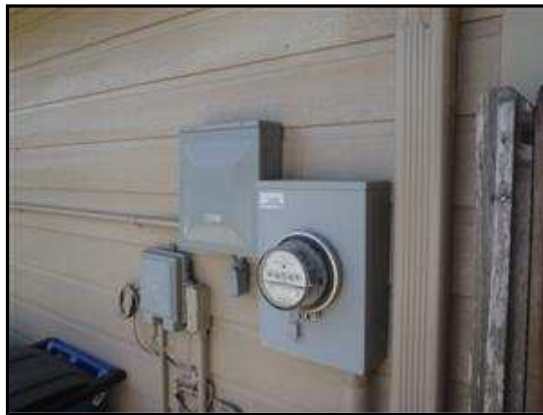
A. Picture 1

(1) The meter base and HVAC disconnect boxes are not sealed on the top and sides as required. Recommend using either mortar or a silicone caulk to seal against moisture intrusion. A qualified person should repair as needed.

E3505.8 Raceways to drain.

Where exposed to the weather, raceways enclosing service-entrance conductors shall be raintight and arranged to drain. Where embedded in masonry, raceways shall be arranged to drain.

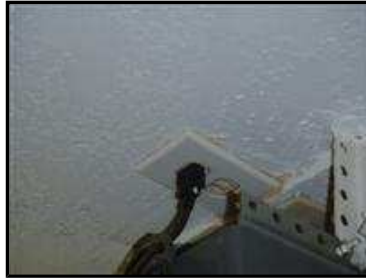
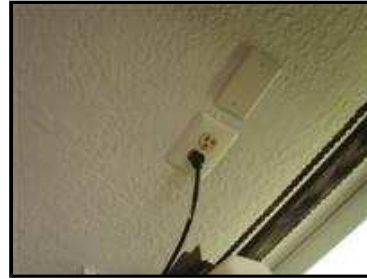
Exception: Receptacles installed for appliances in dedicated spaces, such as for dishwashers, disposals, refrigerators, freezers, and laundry equipment.

Any home built after September 1, 2008 in Texas are required to adhere to this code. Any upgrades after this date must comply with the new codes. Any home which is not equipped with these devices in the required locations is considered deficient by the 2008 TREC Standards of Practice. GFCI (Ground Fault Circuit Interrupter) outlets are not present in 'wet areas' at the **garage ceiling** of this home. This is a safety issue that needs to be corrected. A qualified licensed electrical contractor should perform repairs that involve wiring.

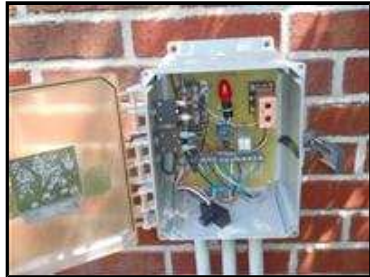
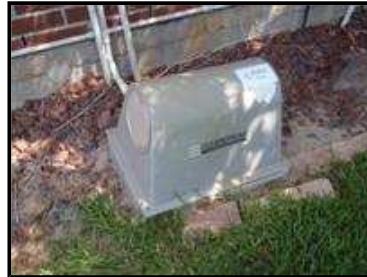
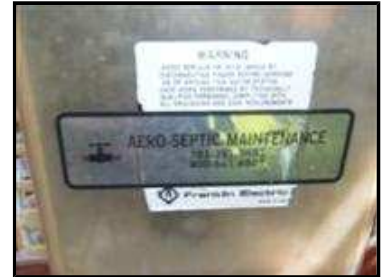
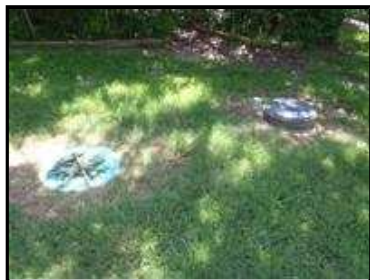
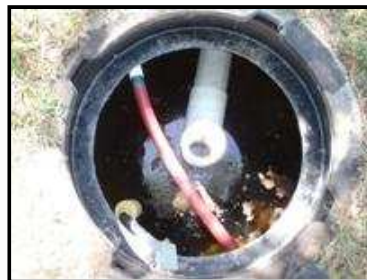
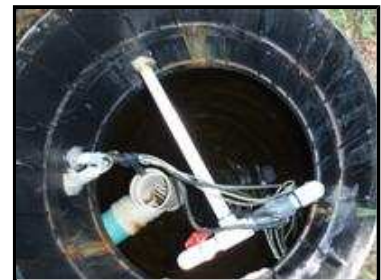
(1) I inspected the property in the location of the drain field area of septic. **All access lids need to be properly secured to prevent access by pets or children.**

There were no signs of failure or blockage and the grounds appear normal. I did visually locate the septic tanks. I **did not** inspect the tank and drain lines for size or condition. A registered sanitarian should be contacted for this activity. Changes in water volume use can sometimes have an impact on septic tanks that before were working properly. Most septic contractors recommend that if the septic tank hasn't been pumped and inspected in the last 4-5 years, you should have it pumped and inspected visually during the inspection process to determine its true condition.

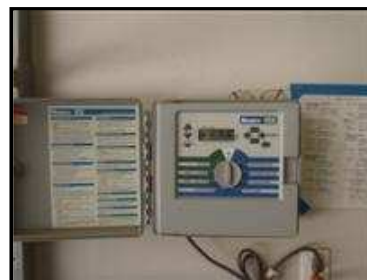
E. Picture 1

1. Zone 3 (right front flower beds) has weak pressure. Repair as needed.

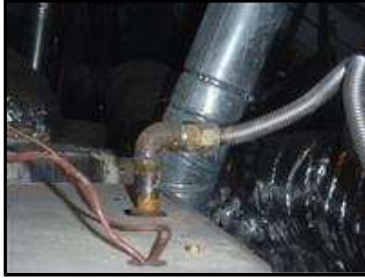
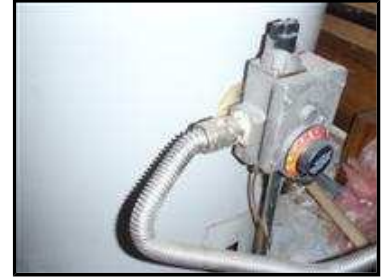
📌 (2) A sediment trap is missing at the furnace(s) and water heater(s). Sediment traps are required on all gas lines just forward of the appliance served.

sediment trap shall be either a tee fitting with a capped nipple in the bottom opening of the run of the tee or other device approved as an effective sediment trap. Illuminating appliances, ranges, clothes dryers and outdoor grills need not be so equipped.

(2) A sediment trap is missing at the furnace(s) and water heater(s). Sediment traps are required on all gas lines just forward of the appliance served.
