P H A P O R D T

Report Identification: Phased Inspection Address

1. Phase Two Guideline

2. Foundation/Slab and Rough Framing

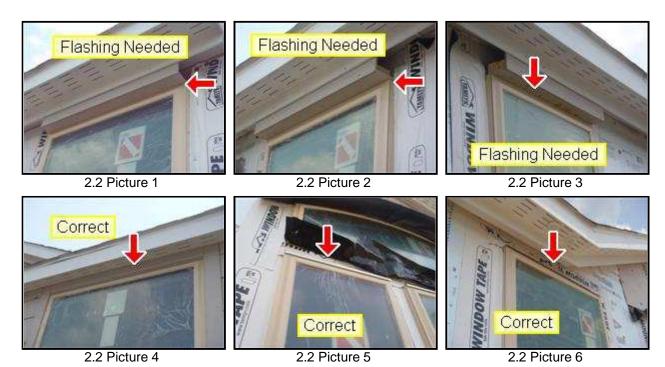
🚹 (1) Flash all window openings, unless fully surrounded by a masonry veneer and capped by a lintel. Some windows have been properly flashed. Some have not. The windows that have not been flashed appear to be those that will be surrounded by a masonry veneer. However, these windows will not be capped by a lintel and will not have masonry veneer over the top of the window. Therefore, since a cement fiber siding material is installed above the window, proper flashing must be installed.

R703.8 Flashing.

Approved corrosion-resistant flashing shall be applied shingle-fashion in such a manner to prevent entry of water into the wall cavity or penetration of water to the building structural framing components. The flashing shall extend to the surface of the exterior wall finish. Approved corrosion-resistant flashings shall be installed at all of the following locations:
