Inspection Report

Property Address:
12345 Inspected Home
Inspection City TX 77001

Texas Real Estate Inspection Services, Inc

PROPERTY INSPECTION REPORT

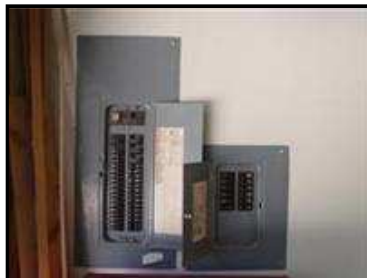
A. Picture 2

(2) The main and sub panel boxes are located at the garage(interior and exterior).

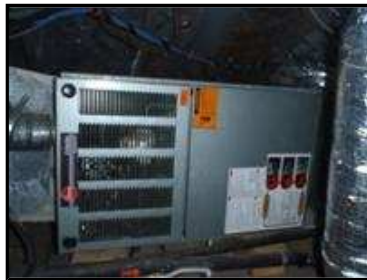
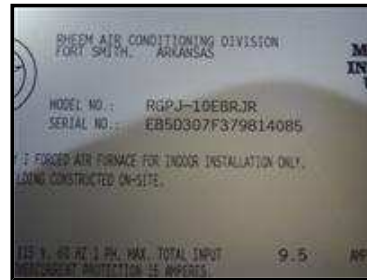
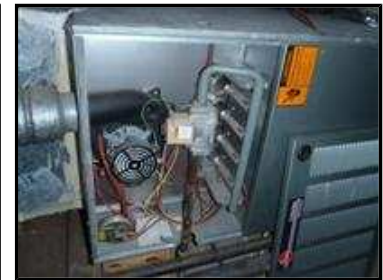
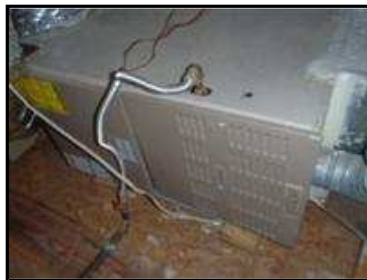
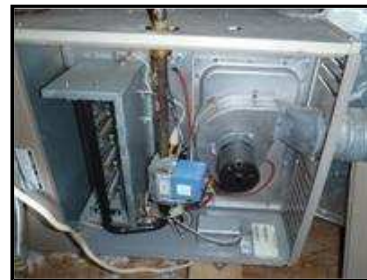
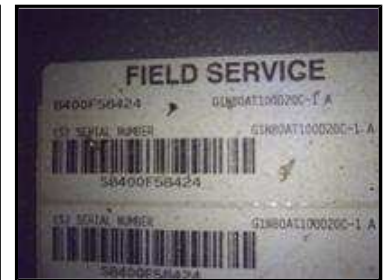
Turned up thermostat(s) and the unit(s) fired as expected.

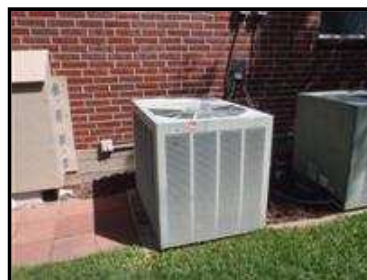
B. Picture 1

(1) An ambient air test was performed by using thermometers on the air handler of Downstairs Air conditioner to determine if the difference in temperatures of the supply and return air are between 14 degrees and 22 degrees which indicates that the unit is cooling as intended. The supply air temperature on your system read 53 degrees, and the return air temperature was 73 degrees. This indicates the range in temperature drop is normal.

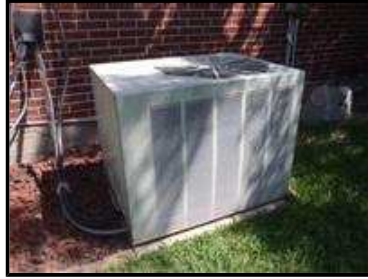
B. Picture 3

(2) An ambient air test was performed by using thermometers on the air handler of Upstairs Air conditioner to determine if the difference in temperatures of the supply and return air are between 14 degrees and 22 degrees which indicates that the unit is cooling as intended. The supply air temperature on your system read 53 degrees, and the return air temperature was 75 degrees. This indicates the range in temperature drop is normal.

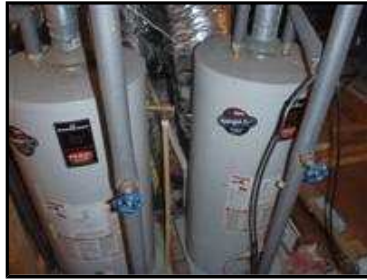
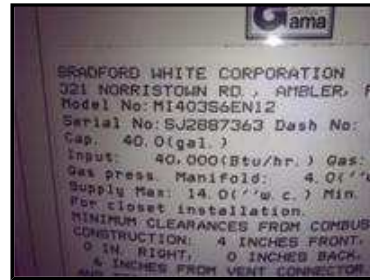
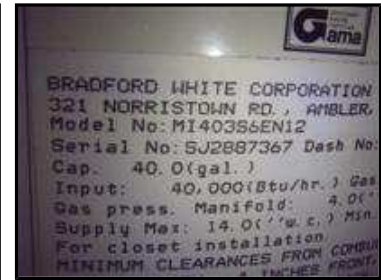
The water heaters were inspected and appear to be functioning as intended. A 1.5" minimum pan is present. TPR valve lines are configured properly as well as the overflow drain line. Both are gravity fed to the exterior and the TPR valve terminates between 6" and 24" above grade.

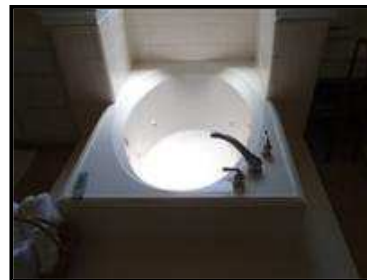
D. Picture 1

The jet tub appears to be functioning as intended at the time of inspection.

GFCI overcurrent protection device for the jet tub is located at Master bath.

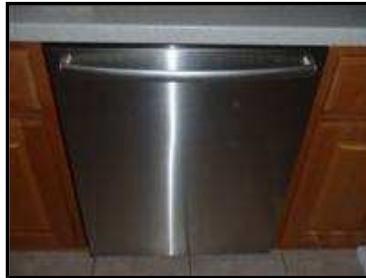
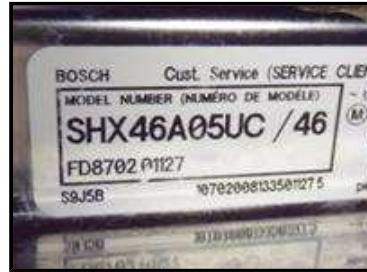
Dishwasher appears to be functioning as intended at the time of inspection. Completed normal cycle in 90 minutes or less. No broken or missing parts were observed.

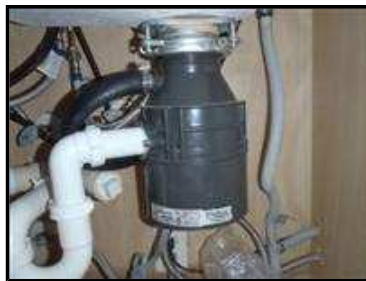
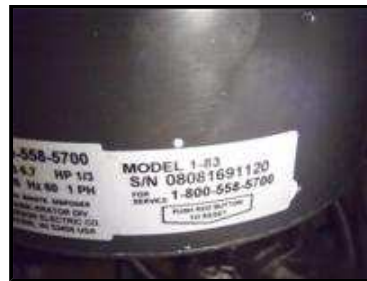
Appears to be functioning as intended at the time of inspection. Splash guard present. No unusual vibrations or noise detected.

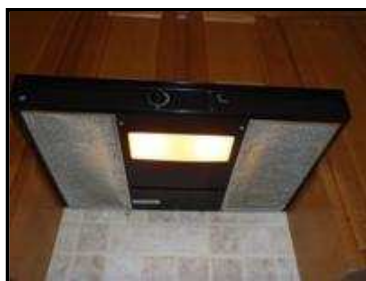
C. Picture 1

Appears to be functioning as intended at the time of inspection. Tested on all speeds.

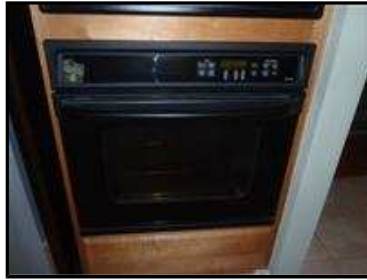
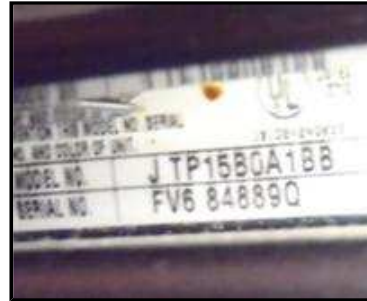
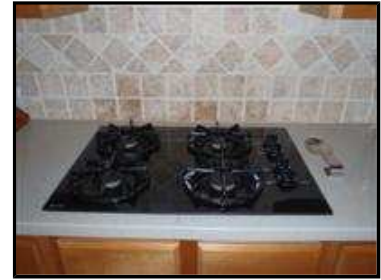
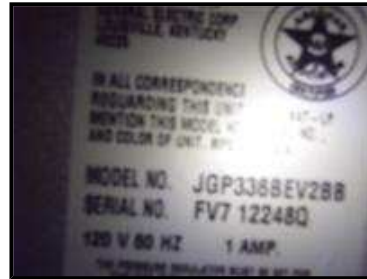
Ranges/Ovens/Cooktops appear to be functioning as intended at the time of inspection. All burners tested on low and high. Oven preheated to 350 degrees, within 20 min the final temperature was measured at 359 degrees. This is within the +/- 25 degrees required

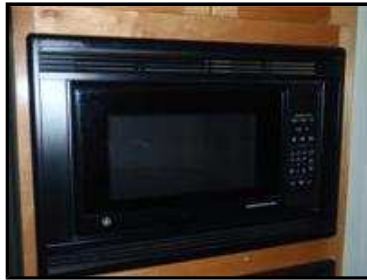
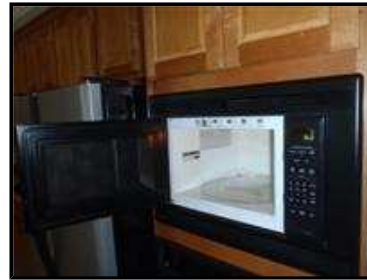
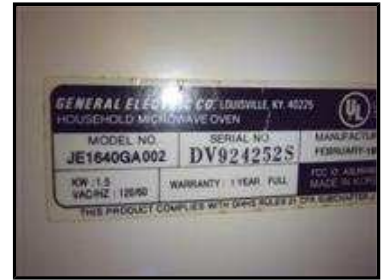
The Microwave cooking equipment appear to be functioning as intended at the time of inspection. Heated one cup of water for 2 minutes to 215 degrees. No broken or cracked glazing. No damage to seal.
